Tecniplast Emerald EM500 Individually Ventilated Cages Allergens Containment Test

Biological Support Unit (BSU), Babraham Institute, Cambridge, UK

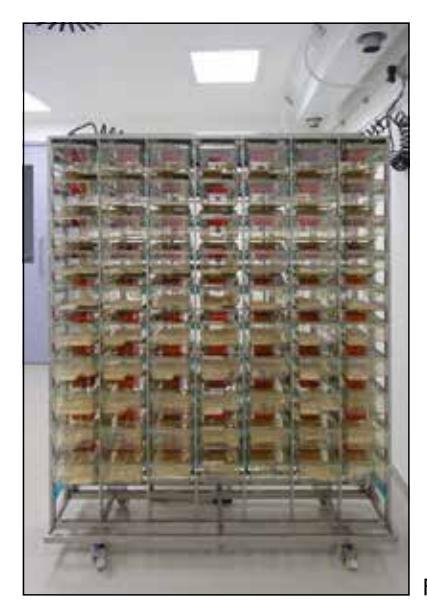
Figure 1

- The bottom row of the rack was not in use for the duration of the trial - fourteen self-sealing nozzles were installed across the bottom row of the rack to prevent any egress ingress of airflow within the unused spaces (Figure 1).
- Cages were given one type of bedding Datesand Grade
 With volume of bedding as per BSU standard (approx. 50 grams per cage).

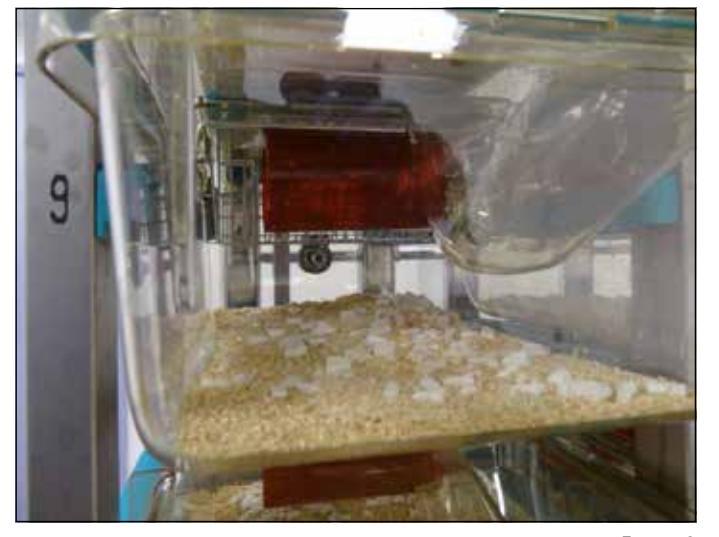
Figure 2

- 4. Nesting used Enrich-o-nest. Approx. volume of nesting was 10 grams per cage (Figure 2).
- 5. Cages were equipped with red plastic tunnels attached to the wire bar lids to function as an escape area in the event of the cage flooding.
- 6. All equipment was autoclaved into the unit (121°C cycle).

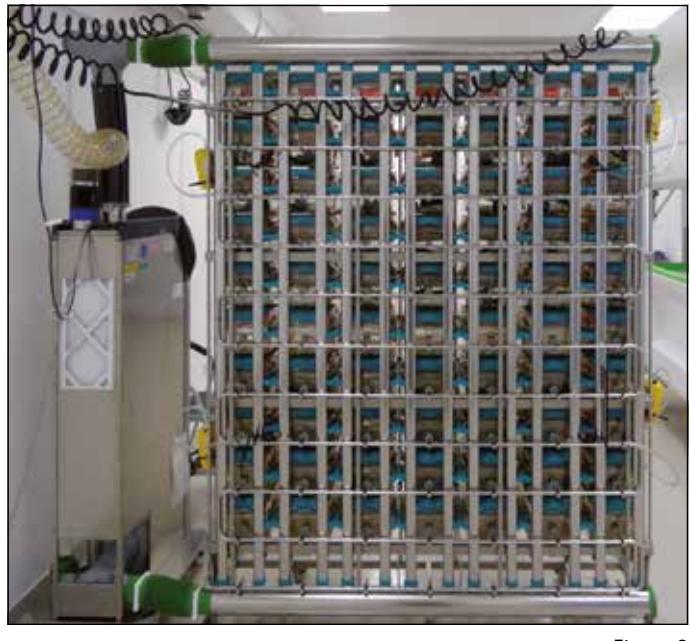
Figure 3

- 7. 70% of cages were populated with mice.
- 8. 34 cages contained stock animals (17 cages of males and 17 cages of females).
- 9. 15 cages contained breeding trios (with or without offspring).
- 10. Weekly cage occupancy was recorded at the beginning of the week, see TABLE A, B and C.
- 11. Allergen pumps (Figure 3 and 4) set up for a duration of eight hours (standard working day).
- 12. Filters were added to allergen monitoring pumps within a Class 2 MSC.
- Allergen samples were stored in a fridge until the end of the trial; all samples sent together to the Health and Safety Laboratory in Buxton.
